Pyramid Technical Consultants, Inc.
1050 Waltham Street Suite 200
Lexington, MA 02421

Recommended I404 Firmware Update

Rev: 1
Date: 03 Dec 2009

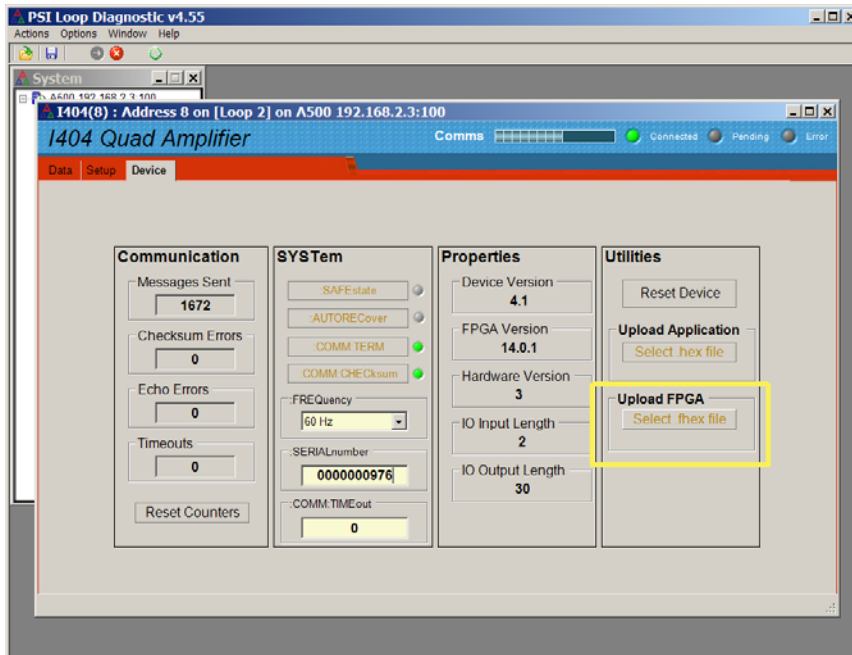
- 1) Download the updated PSI Diagnostic host installer for version 4.55 from the web site.
- 2) Run the .msi file on a Windows PC to install the PSI Diagnostic.
- 3) Get the uploadable FPGA code file I404_FPGAD14-0-11_091126.fhex and the uploadable application code file I404_PIC-4_11_091125.hex from the web site and save them to a convenient location on the PC.
- 4) Run the PSI Diagnostic and connect to the I404.
- 5) On the Device tab, click the Upload FPGA button and navigate to the FPGA code file.

Let the upload complete. Do not turn off the power or the PC while the upload is in process.
